**MAJOR REPAIR AND ALTERATION**  
**(Airframe, Powerplant, Propeller, or Appliance)**

<b>1. Aircraft</b>	Make Gulfstream	Model 690D
	Serial No. 15018	Nationality and Registration Mark N611
<b>2. Owner</b>	Name (As shown on registration certificate) United States Department of Interior	Address (As shown on registration certificate) Office of Aircraft Services 300 E. Mallard Dr. STE. 200

N611 Gulfstream Twin Commander 690D      AFTT:10207.3      09/11/06  
Repaired Center Floor Beam Web P/N: 310903-3, IAW GTEC 8110-3 DWG 06-3951.  
No significant change to weight and balance.

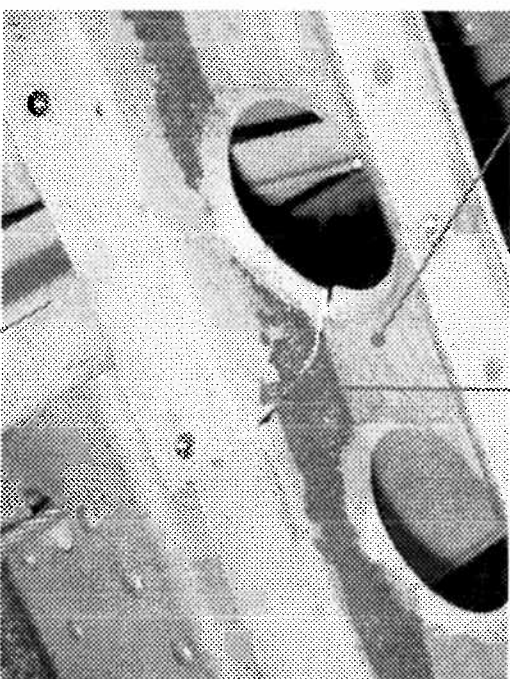
310903-3 CTR WEB  
(REF.)  
MD-EAM0001-3951, ITEM #1  
CRACK INDICATION

1	The center cabin floor beam 310903-3 web has sustained a large crack extending from the parts web at the center lightening hole bead flange bead	R.L.	6-5-06	X	1) <b>REPAIR PROCEDURE:</b> Repair in accordance with GTEC, INC. Drawing No. 06-3951 "CENTER FLOOR WEB REPAIR - MODEL 690D, S/N 15018", Rev. I/R, Dated 11-SEP-2006.	Fred Gatz	11 SEP 2006	
	The crack extends from the right hand side of the bead downward at the 5:00 o'clock position and continues through the lower return flange of the part.							
					<b>ENGINEERING NOTE:</b> This damage appears to be the result from an

**VIEW LOOKING FORWARD & DOWN  
@ THE CENTER FLOOR WEB**
